AMMRC TR 84-39

# MOBILE ACCELERATOR NEUTRON RADIOGRAPHY SYSTEM

W. E. DANCE, S. F. CAROLLO, AND H. M. BUMGARDNER  
LTV AEROSPACE AND DEFENSE COMPANY  
VOUGHT MISSILES AND ADVANCED PROGRAMS DIVISION  
P. O. BOX 650003  
DALLAS, TEXAS 75265-0003

FINAL REPORT

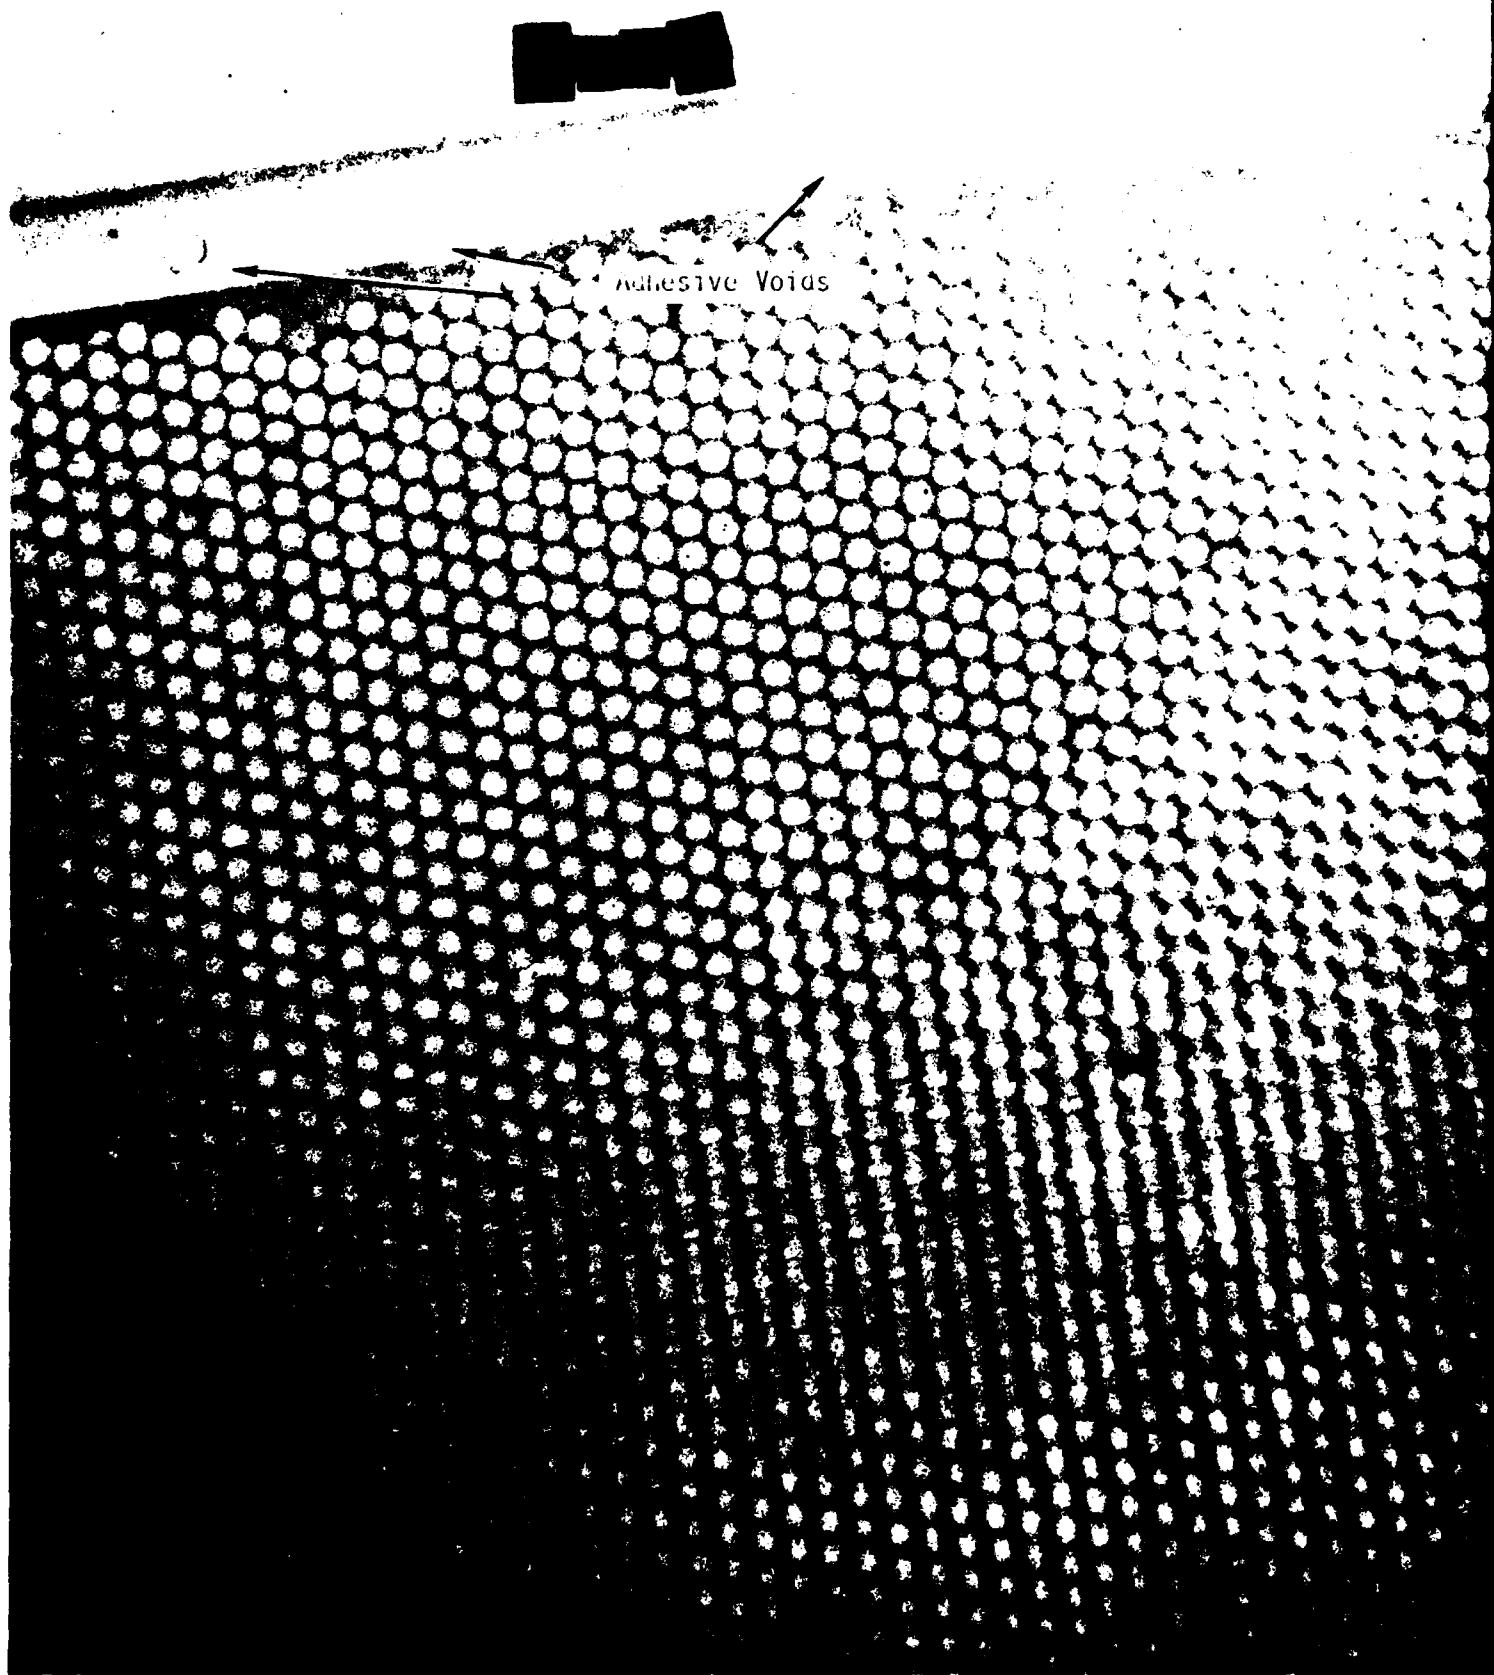
Figure 52N. 15-Minute Neutron Radiograph of Leading Edge of F-111 Vertical Stabilizer Showing "Wormhole" Voids in Adhesive

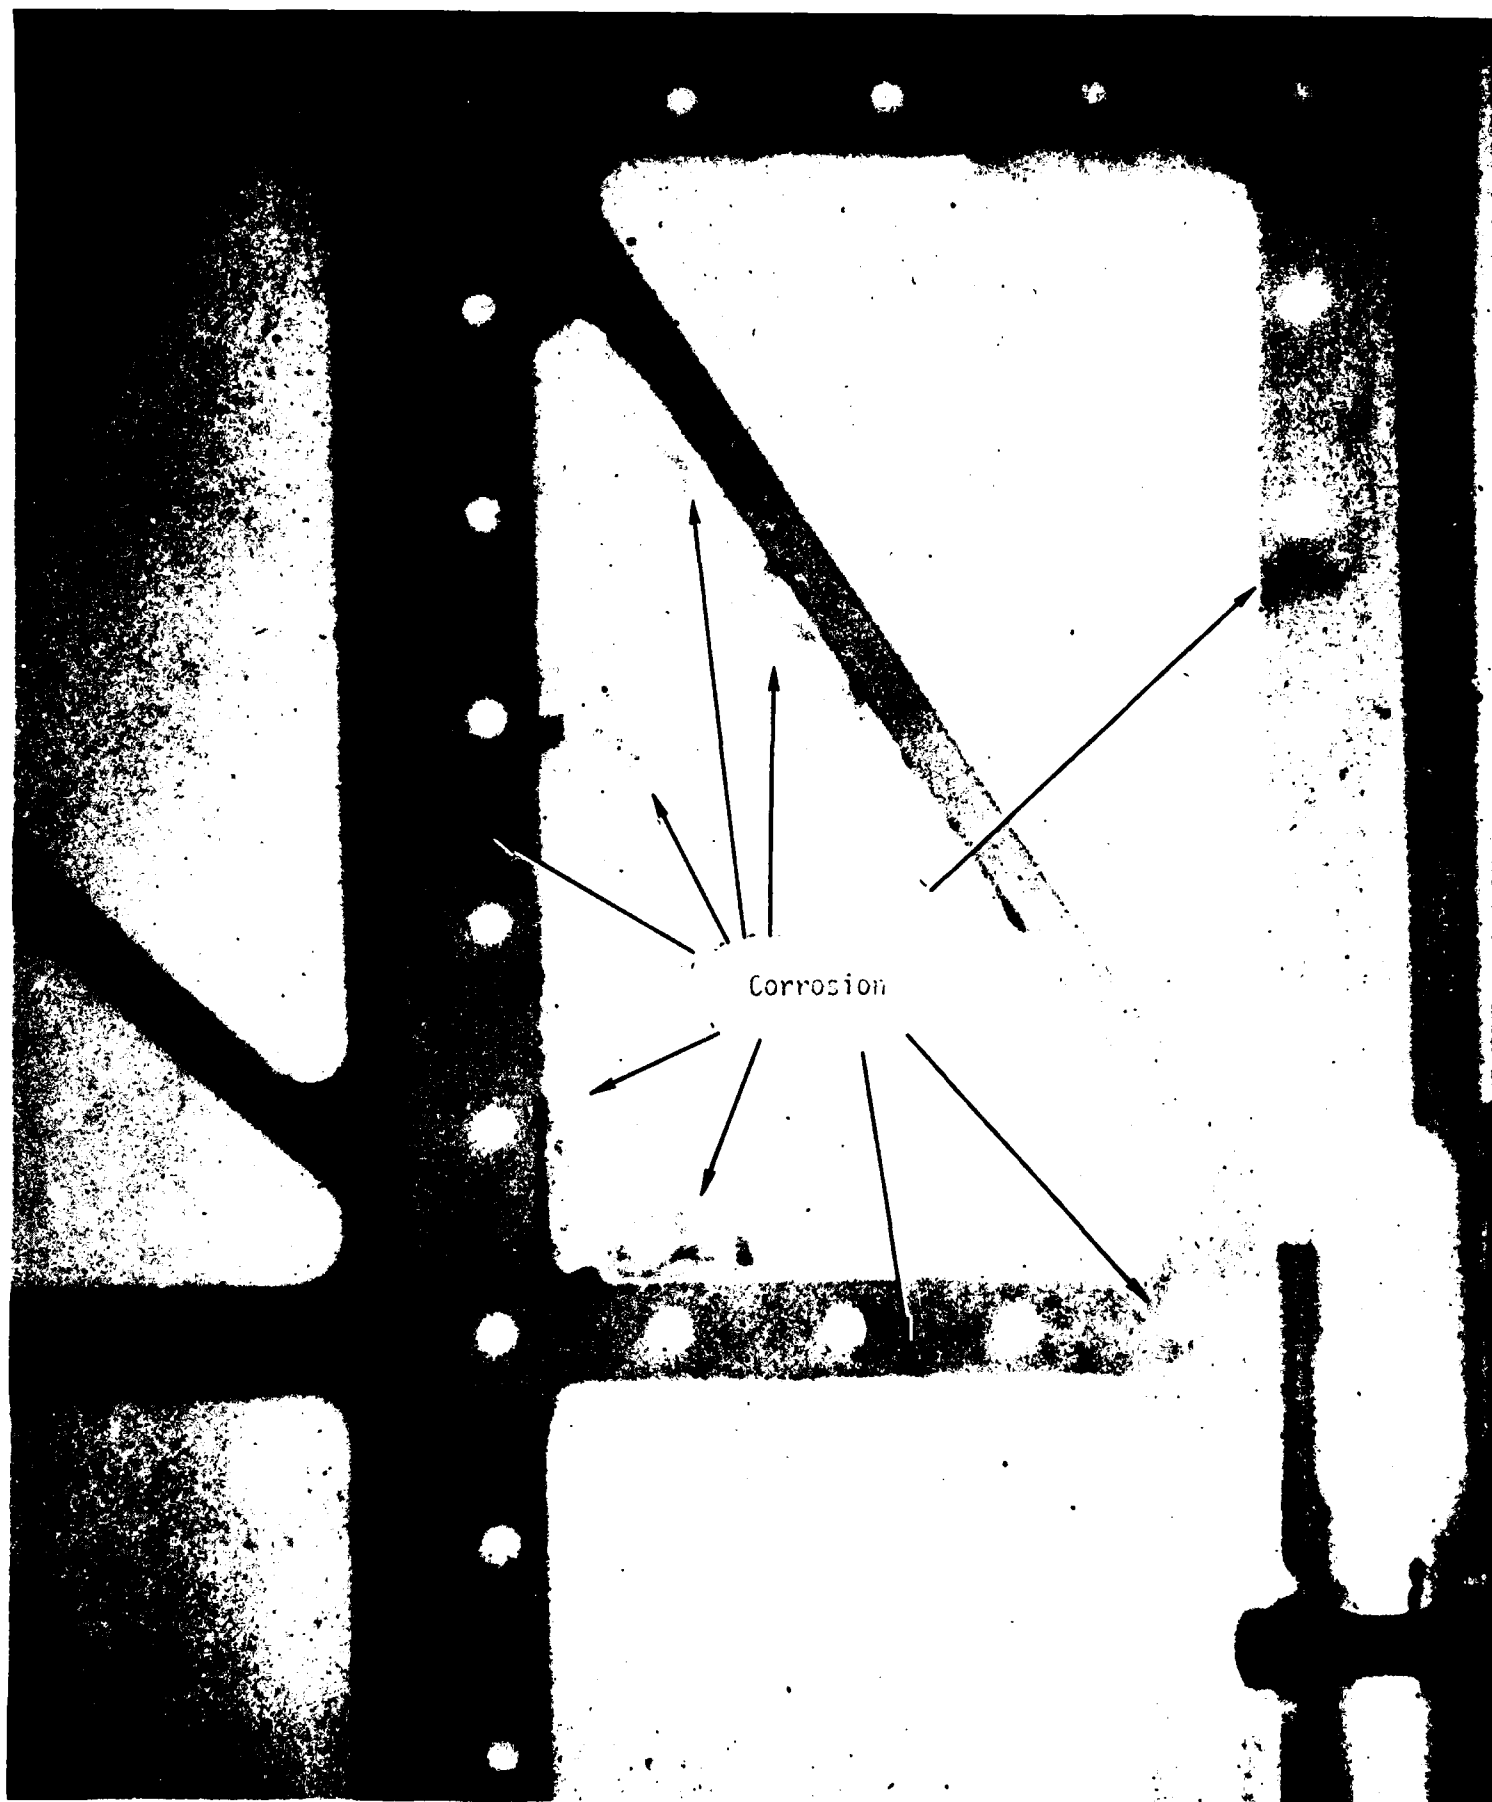
Figure 56N is the neutron image of a T-39 main landing gear door, exhibiting corrosion in the thin aluminum panel between the stiffeners, and in the stiffener itself in some areas. An x-ray of the same specimen is shown in Figure 56X. The x-ray also images the more severe areas of corrosion by indicating loss of metal in those areas and in some cases by imaging moisture.

Figure 56N. Neutron Radiograph of T-39 Main Landing Gear Door Showing Corrosion

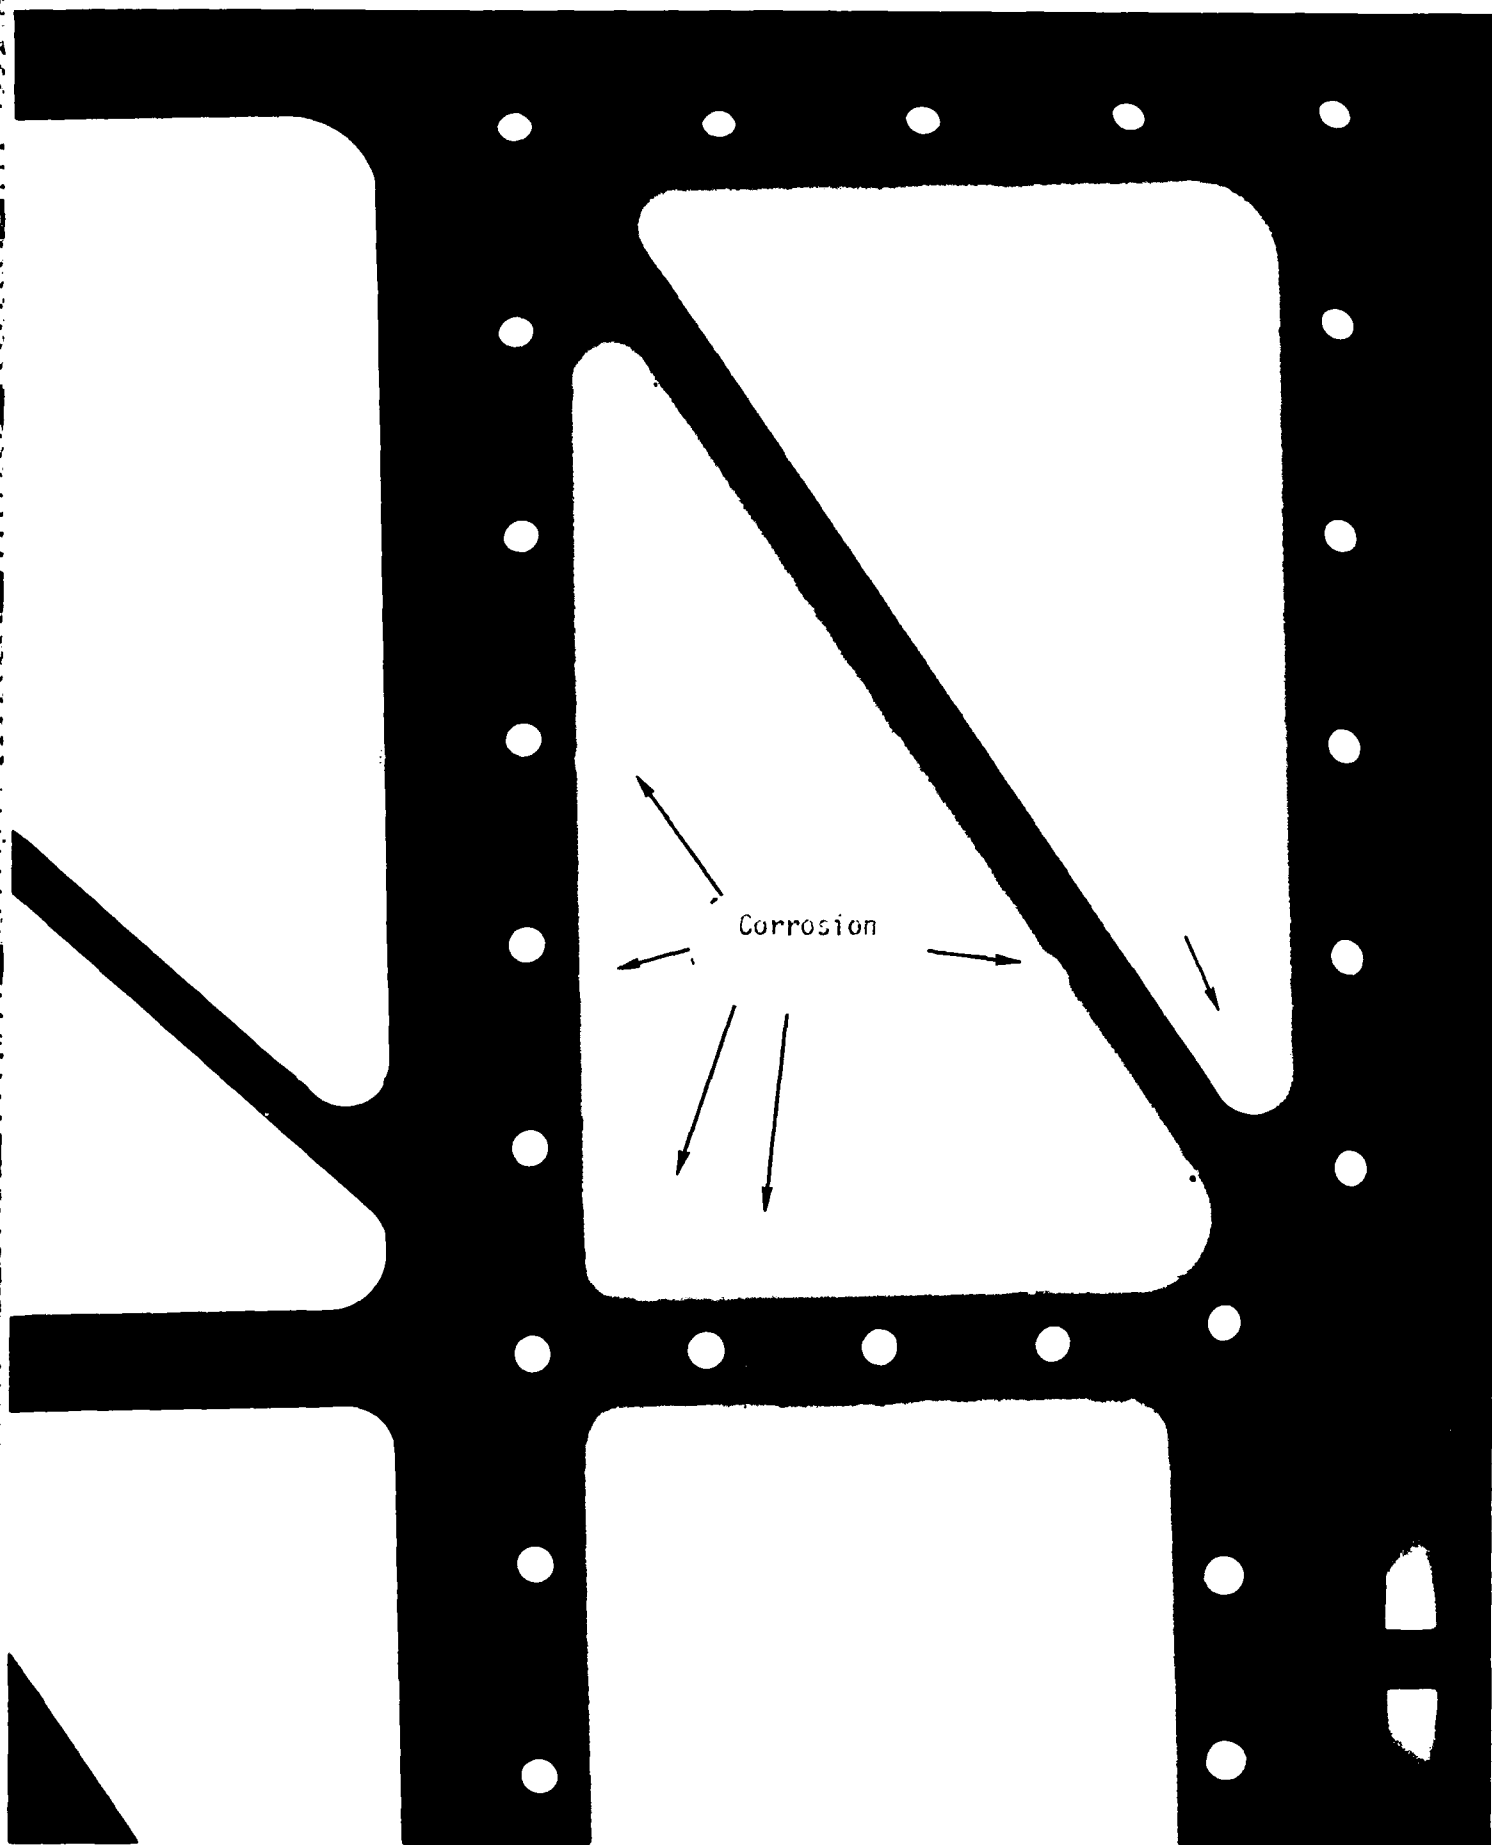
Figure 56X. X-Ray Radiograph of T-39 Main Landing Gear Door Showing Pitted Areas in Thin Webb Area
